Debris/Ice/TPS Assessment And Photographic Analysis For Shuttle Mission STS-33R

Charles G. Stevenson
NASA/Kennedy Space Center

DEBRIS/ICE/TPS ASSESSMENT
AND
PHOTOGRAPHIC ANALYSIS
OF
SHUTTLE MISSION STS-33R

November 22, 1989

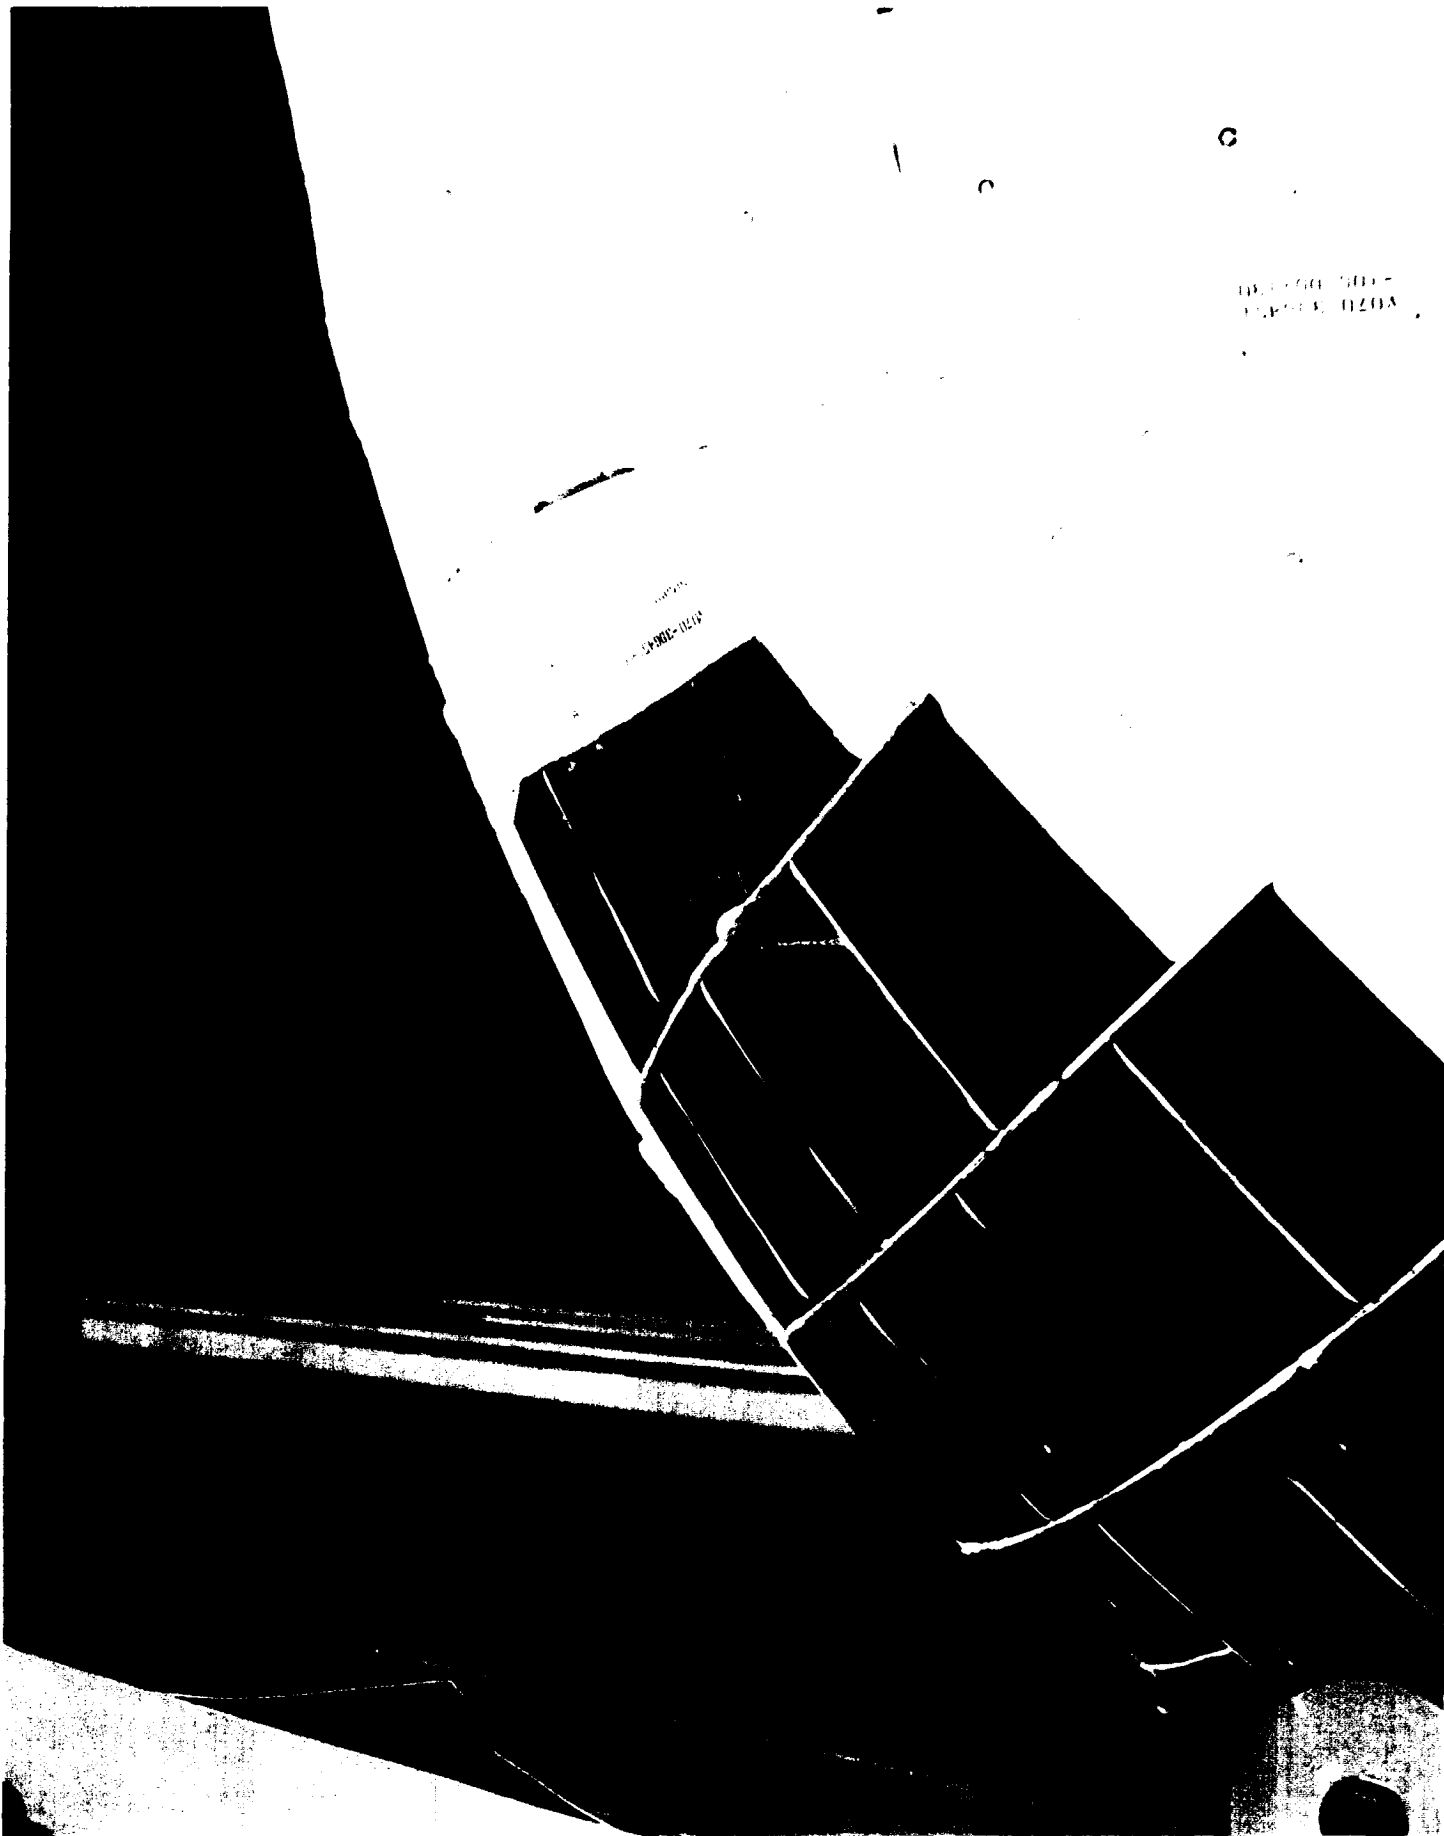
Several pieces of gap filler sleeving material were loose
on the RH OMS pod

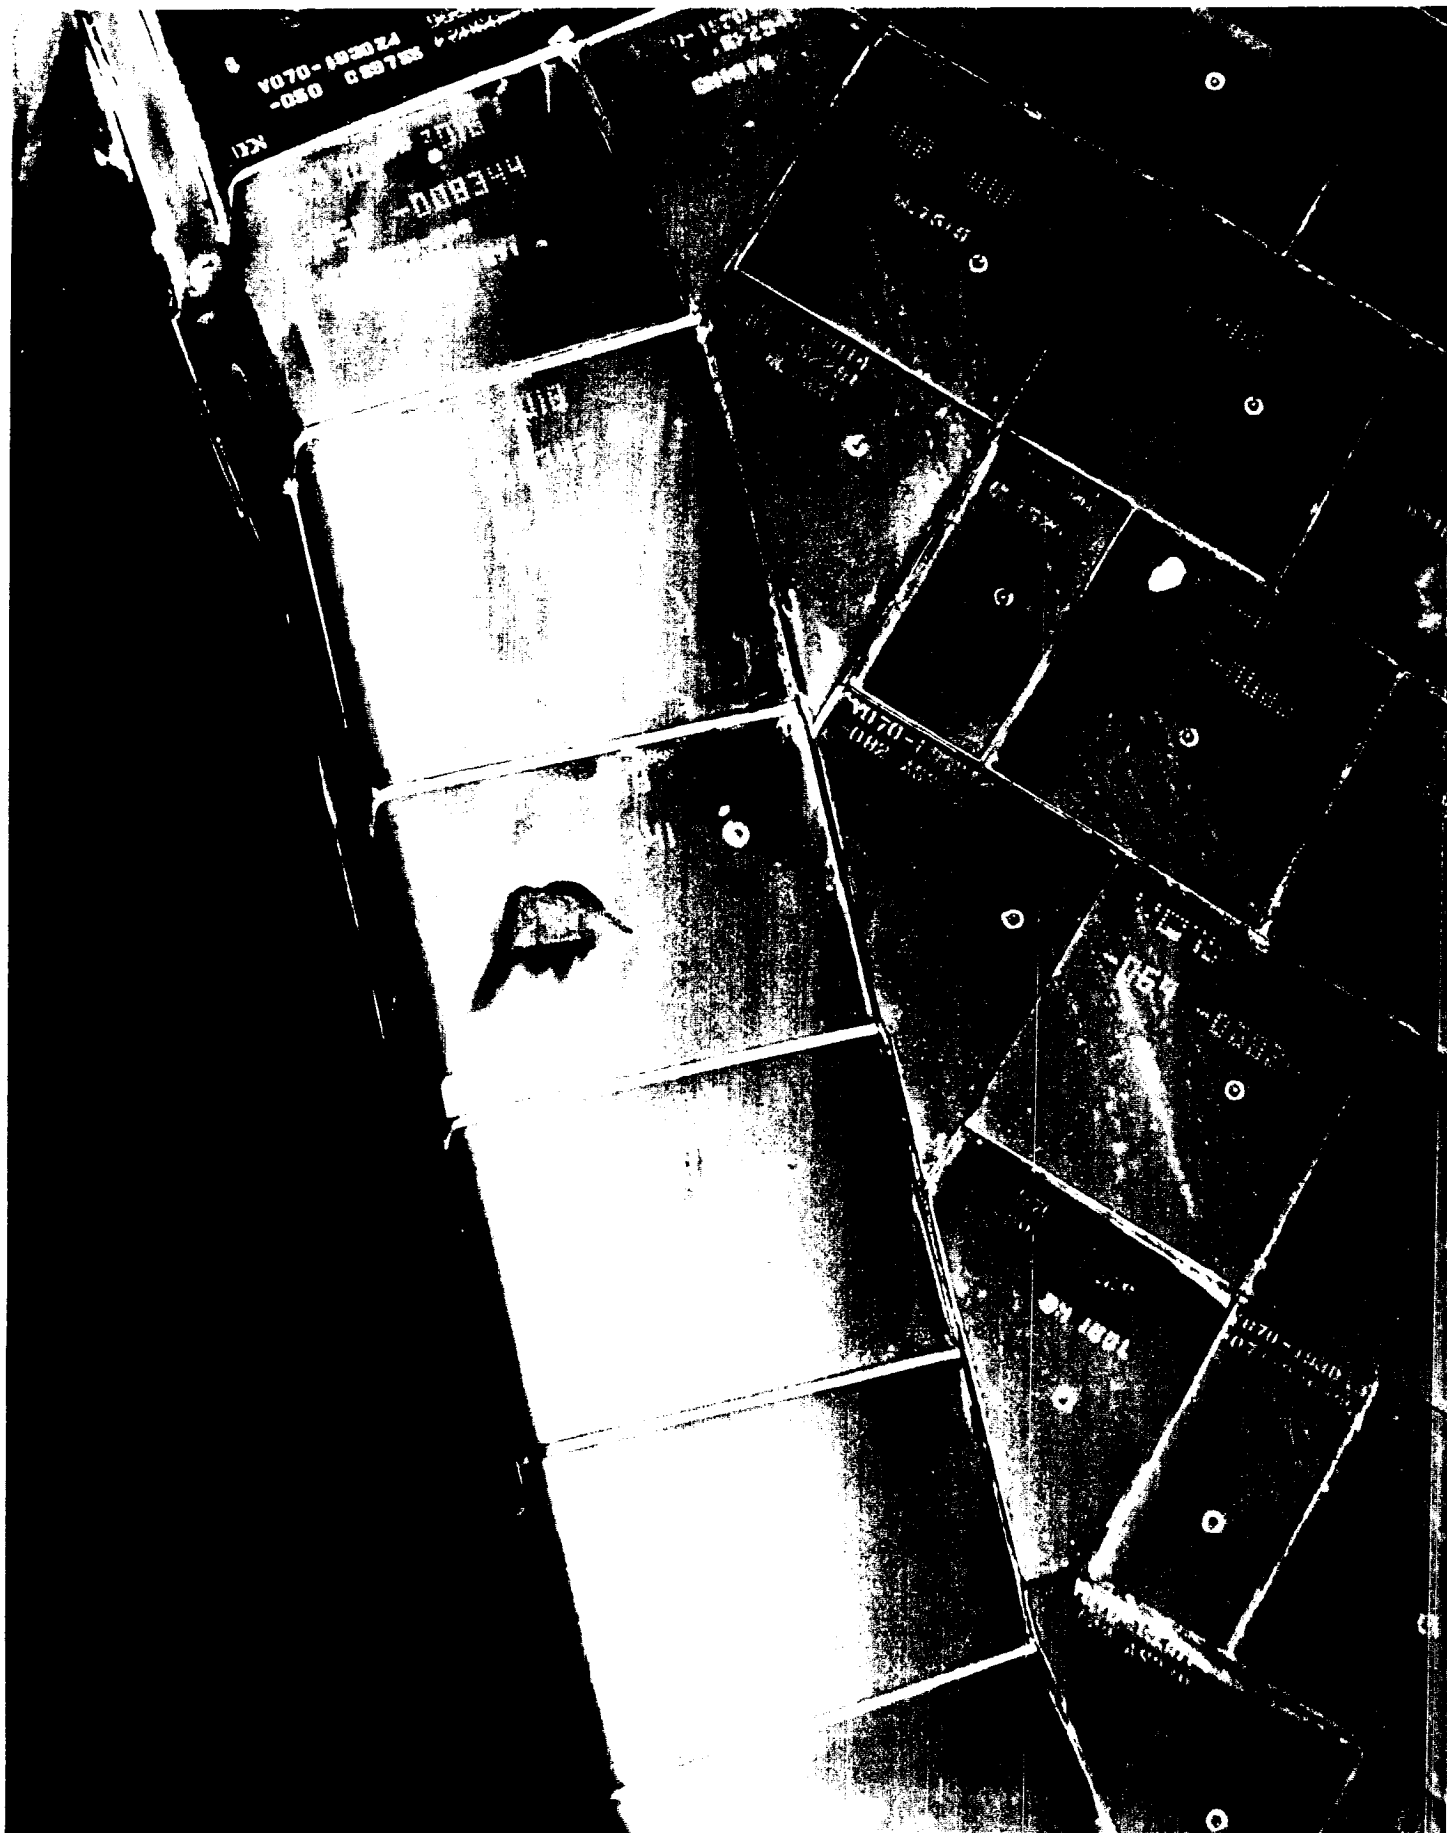
A piece of tape or charred tape residue adhered to the
surface of a tile

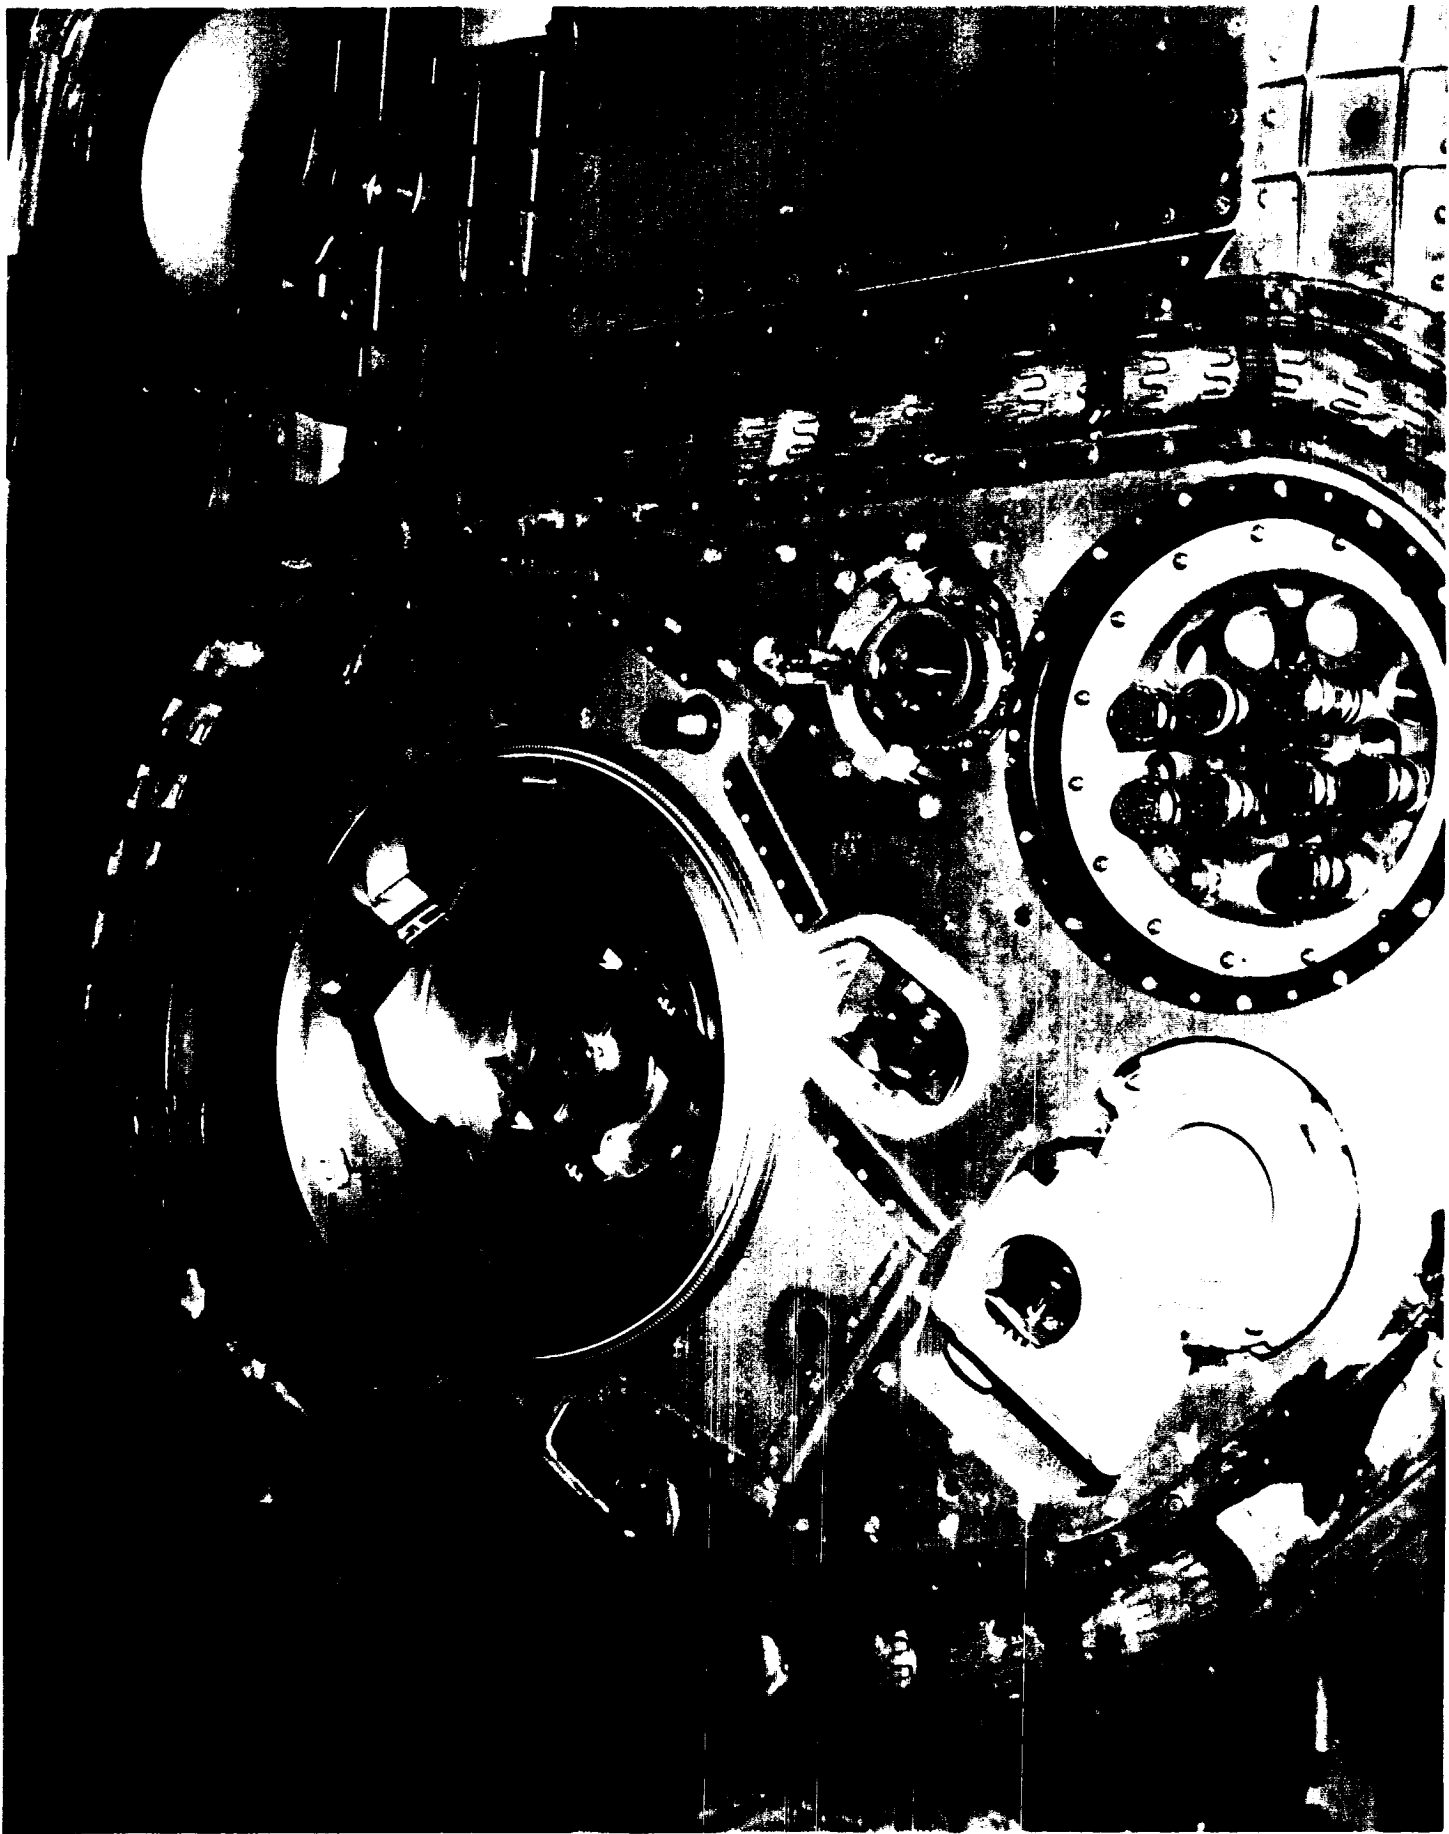
Overall view of ET/ORB LH2 umbilical. Note closeout foam intrusion on the purge barrier sealing surface.

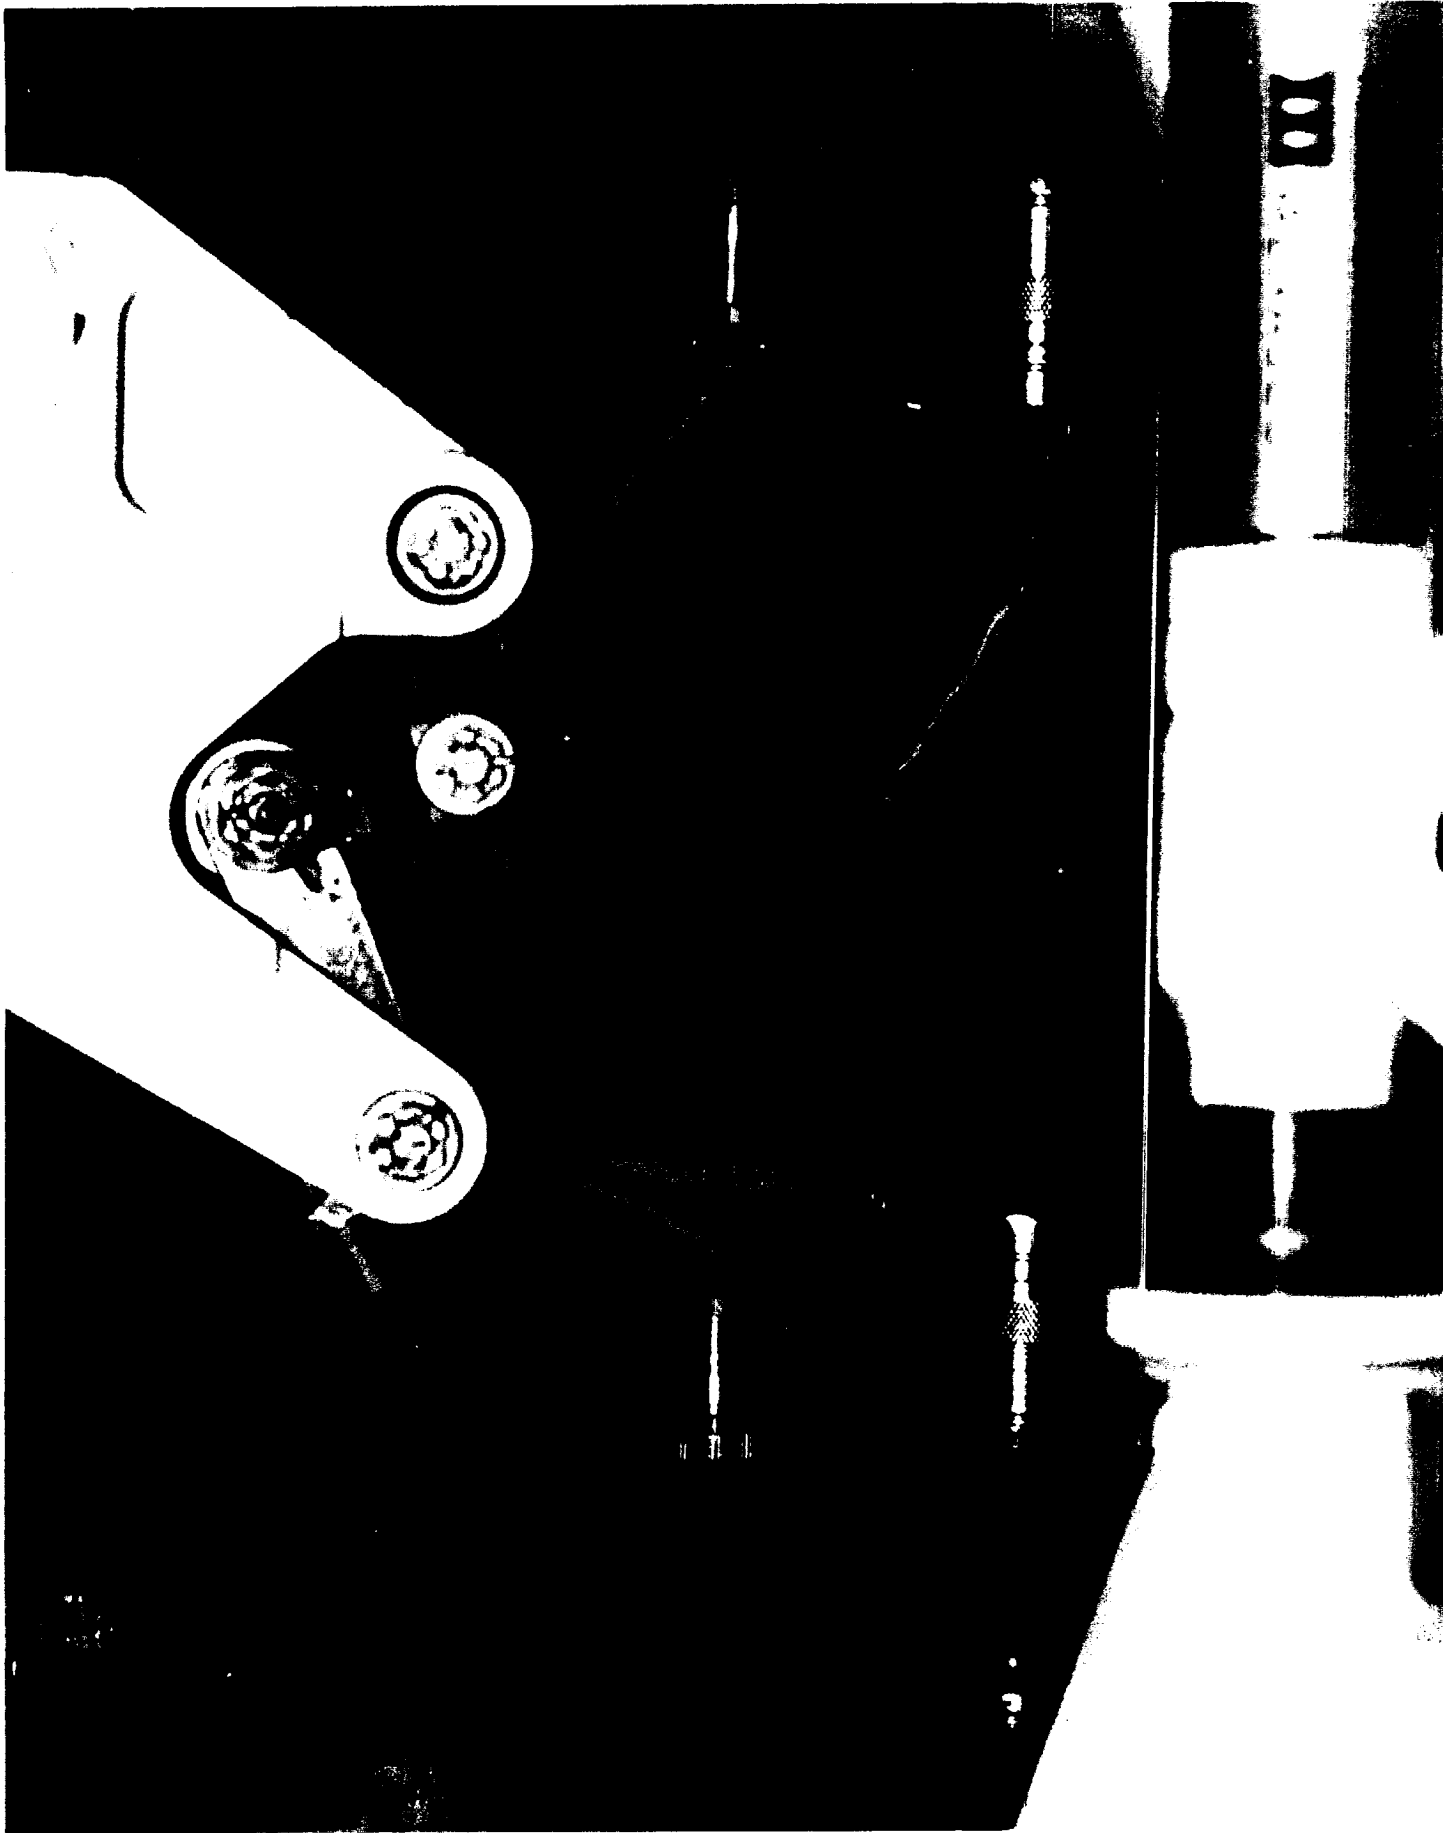
inspection of EO-1 revealed the ordnance device had rotated forward sufficiently to contact and break the LH bulkhead pyrotechnic connector backshell. There is also evidence of this contact on the ordnance device LH spring housing. The Y-Y centering bolt, which had bent on STS-34, was not damaged during this flight.

Inspection of EO-1 revealed a broken LH bulkhead pyrotechnic connector backshell. Note difference from opposite side.
